**EMERALD ASH BORER
MITIGATION
RESPONSE PLAN**

**Vermont Electric Cooperative, Inc.
42 Wescom Road
Johnson, Vermont 05656**

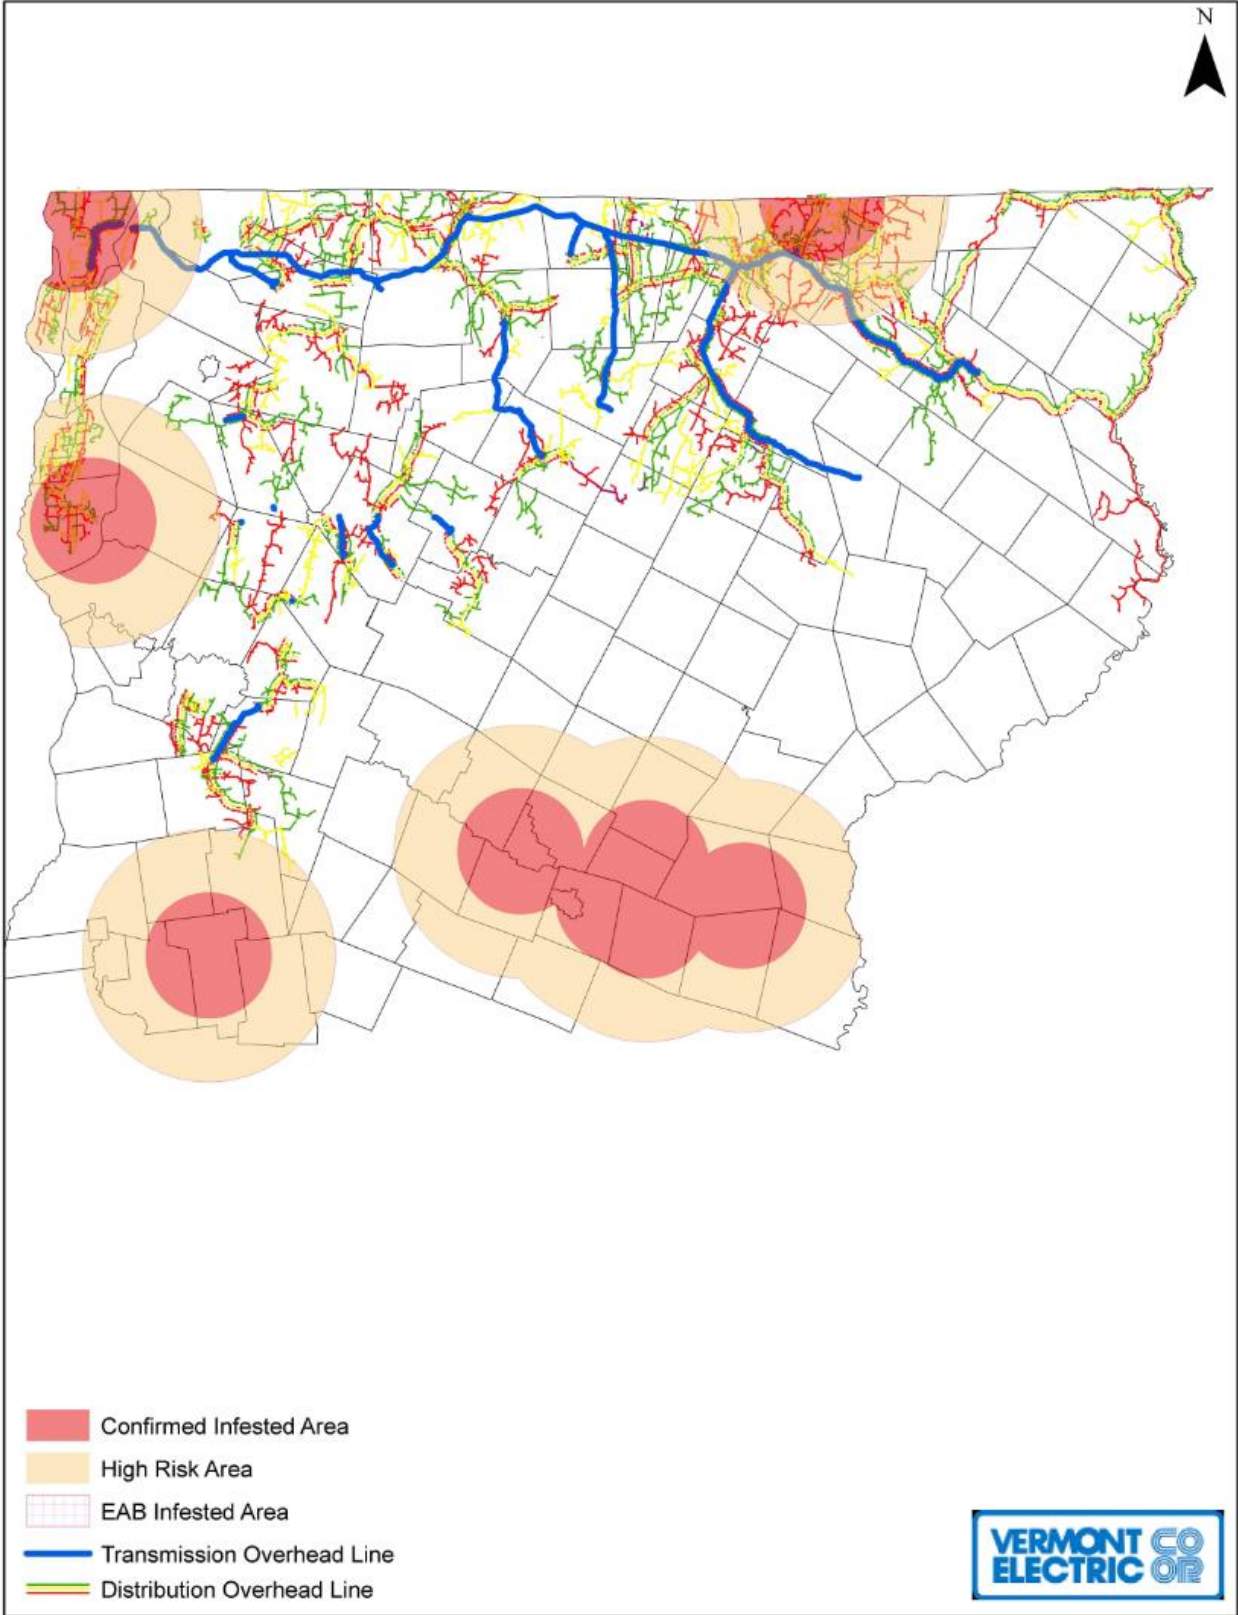
Map of EAB Confirmed Infested and High Risk Areas in VEC Service Territory

EAB confirmed infested areas currently include 10 towns served by VEC (red center of circles on location map). Infestation is suspected and considered high risk in an additional 13 towns (yellow circles around the red centers on location map). There are approximately 239 linear miles of VEC overhead electric lines within the EAB confirmed infested area. The first location to be confirmed within VEC territory was in South Hero in the fall of 2018.

VEC plans proactive ash tree removal within the confirmed infested areas (red circles on location map) across its service territory, beginning with South Hero Substation #29, in accordance with the following guidelines:

- Remove all ash trees within striking distance of VEC primary overhead lines, regardless of specific location or condition within all confirmed infested and high risk areas (red and yellow circles on the location map).

- Remove all ash trees within striking distance of VEC primary overhead lines, regardless of specific location or condition within the confirmed infested areas (red circles on location map). Remove all ash trees in accordance with the guidelines listed in the proposed mitigation above within the high risk areas (yellow circles on the location map).
