Vermont Electric Cooperative, Inc.
Vermont PUC Rule 4.900
2019 Electricity Outage Reporting
January 30, 2020

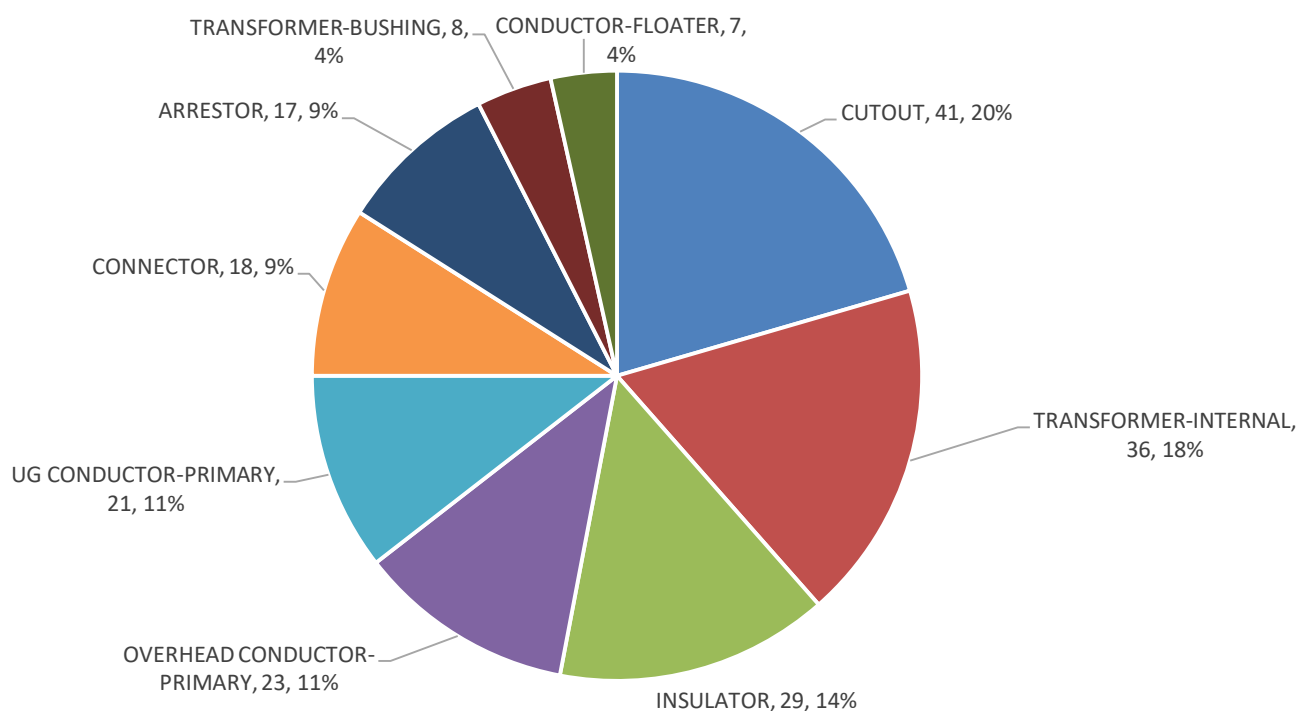
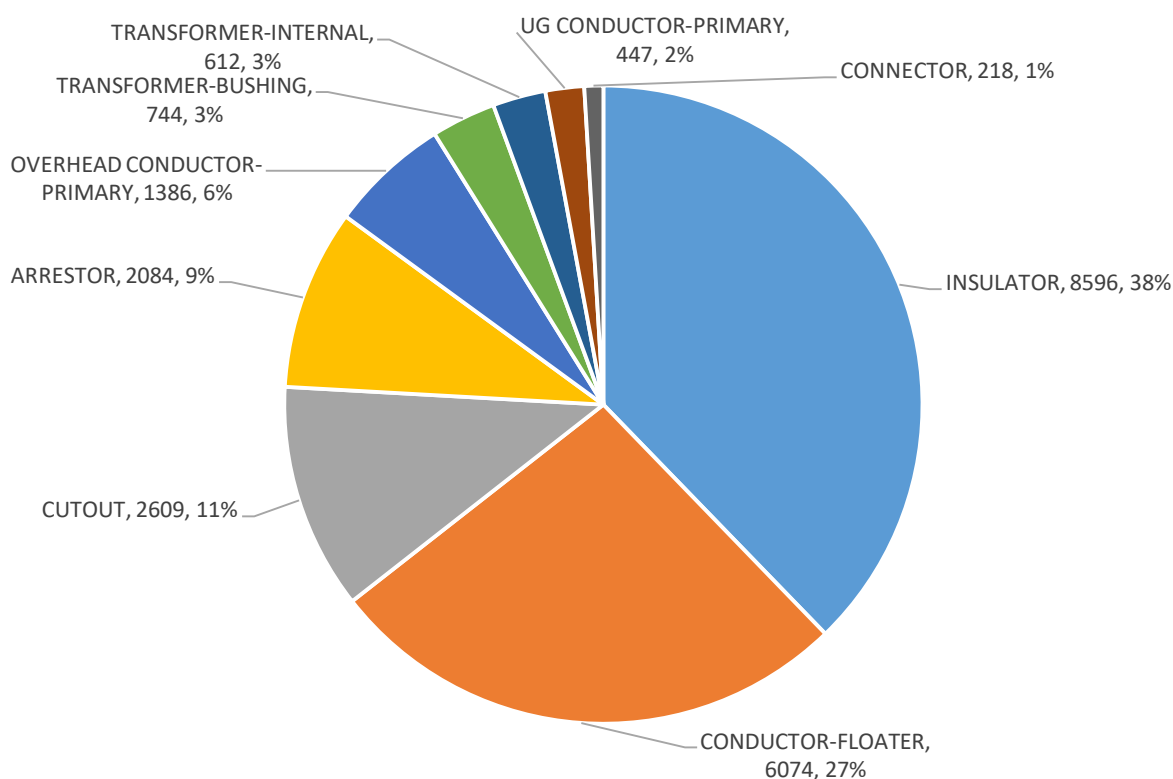
The two charts below show secondary outage codes by quantity and customer hours out.

Cutouts and transformer failures (overload and internal) are the two largest equipment failures by quantity and duration. A ~ 3-hour outage where a conductor that had come untied from the insulator (also referred to as a

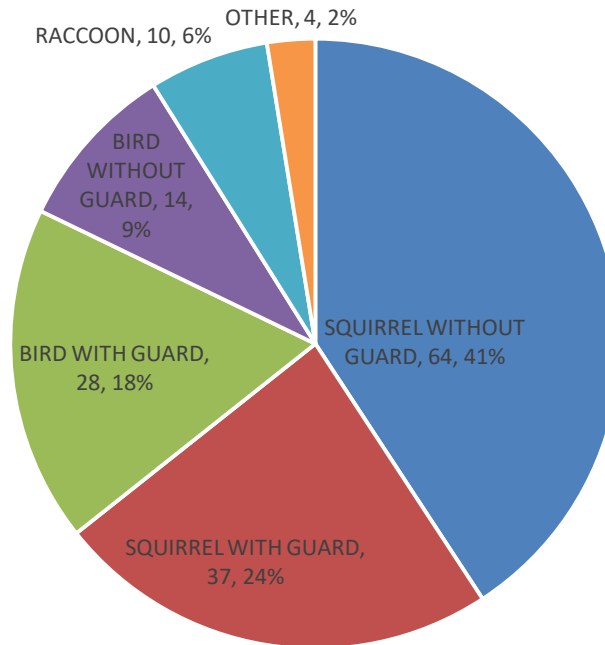
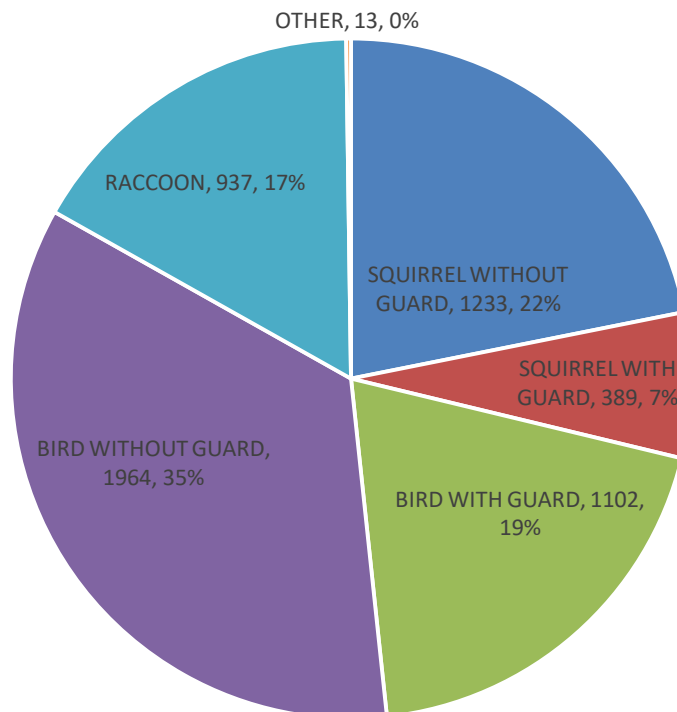
The two charts below show secondary outage codes by quantity and customer hours out.

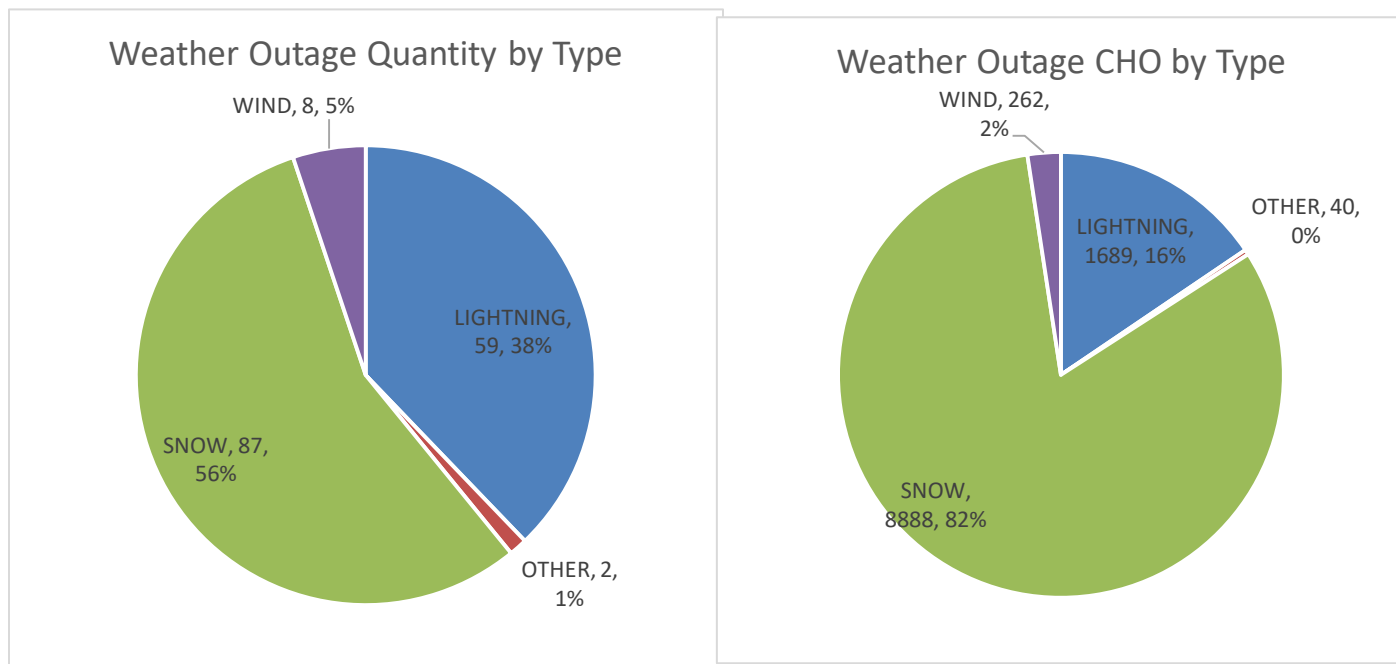
The two charts below show secondary outage codes by quantity and customer hours out.

The primary causes of these outages were snow unloading and lightning. The general trend is that weather-related outages are increasing; however VEC has not been able to draw a causation between wind and precipitation and increased outages. VEC and other state distribution utilities are working with Northern Vermont University – Lyndon to identify how our changing climate is affecting weather hazards (primarily wet snow, ice, and wind storms) and to determine the respective impacts to the power system. The outcome of this research project would be a comprehensive public report discussing current and future weather risks to the grid in Vermont and associated utility impacts. This information will help VEC and other participating utilities better understand the impacts of weather on our grid, modify our philosophies and standards, and find cost-effective solutions to maintain reliability for our members.
