**Vermont Electric Cooperative, Inc.
Vermont PUC Rule 4.900
2022 Electricity Outage Reporting
January 31, 2023**

1 Executive Summary

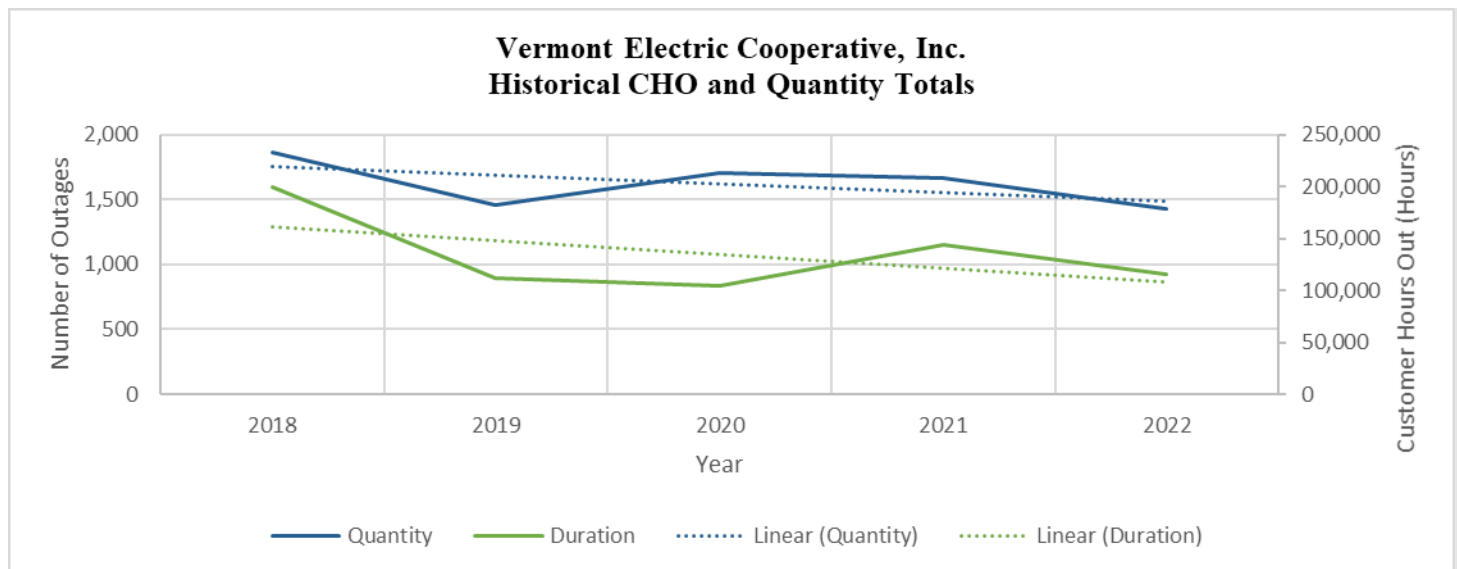
The figure below details VEC’s outage durations and quantity from 2017-2022.

VEC saw a decrease in outage duration and a decrease in outage quantity in 2022. However, the general trends are flat or slightly decreasing. VEC plans to utilize the following process to continue to improve system performance:

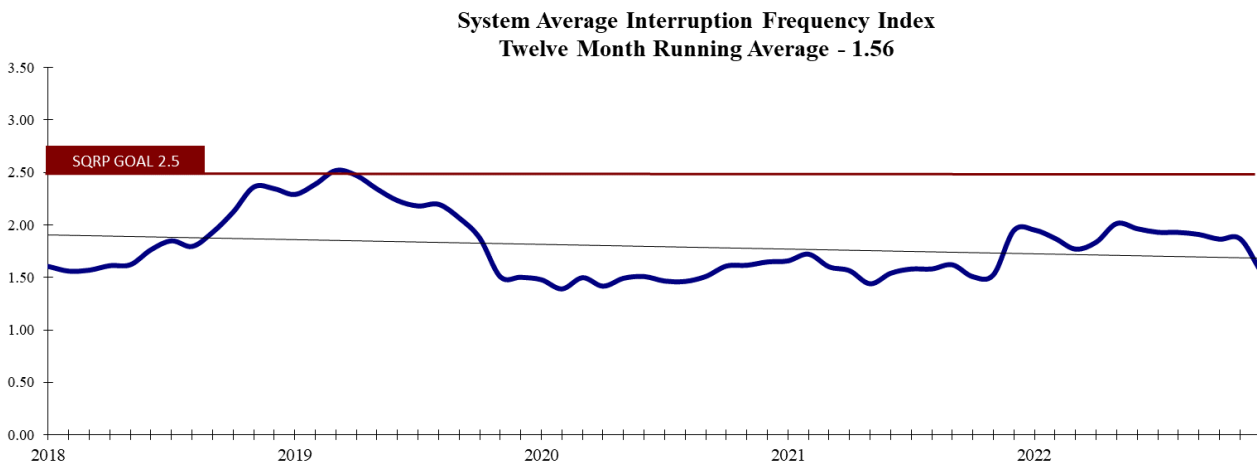
4.1.1 Long Term SAIFI Performance Trend (major storms excluded)

VEC tracks a monthly running twelve-month SAIFI average. The table below shows SAIFI performance back to January 2018.

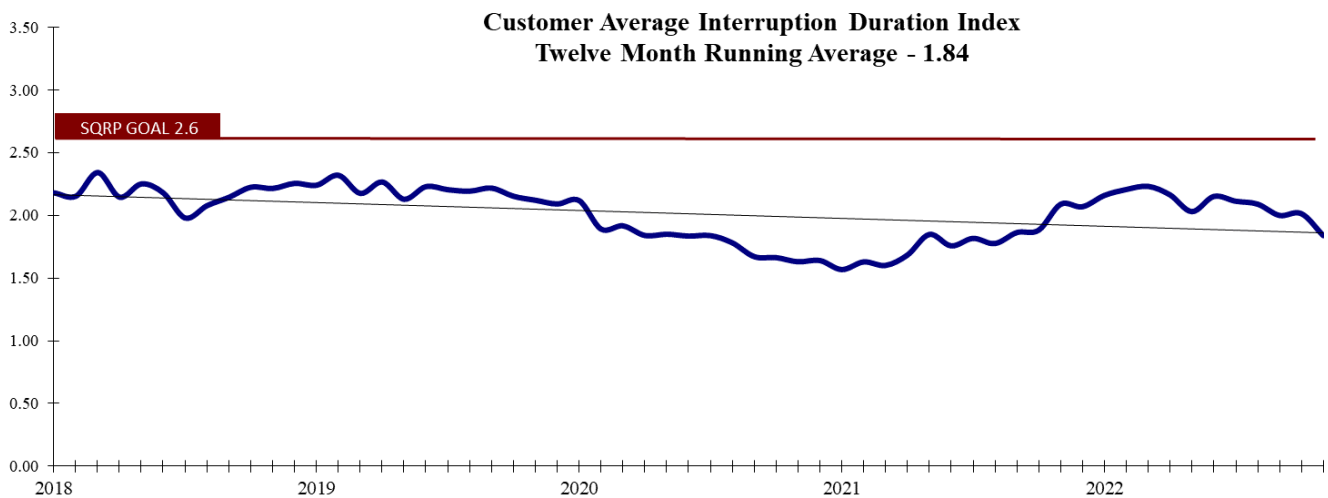
4.1.2 Long Term CAIDI Performance Trend (major storms excluded)

VEC also tracks a monthly running twelve-month CAIDI average. The table below tracks CAIDI performance back to January 2018.

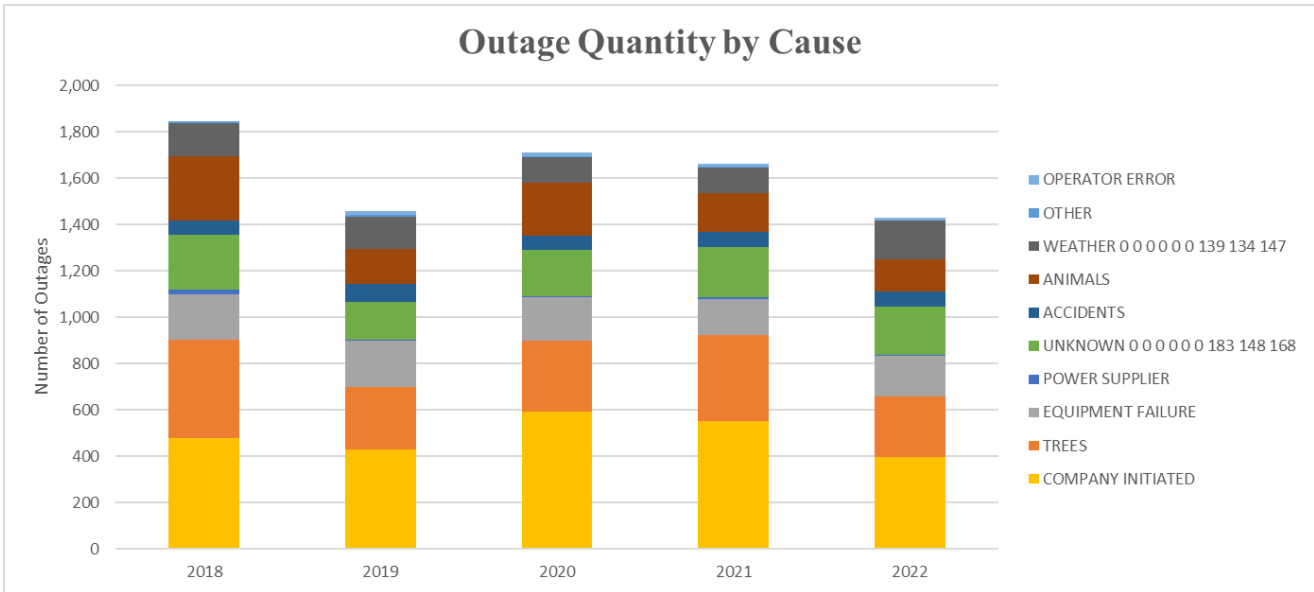
VEC experienced 1,429 outages in 2022 and averaged 1,622 outages per year over the five-year period between 2018 and 2022. The chart below identifies outage quantity by cause for 2018-2022.

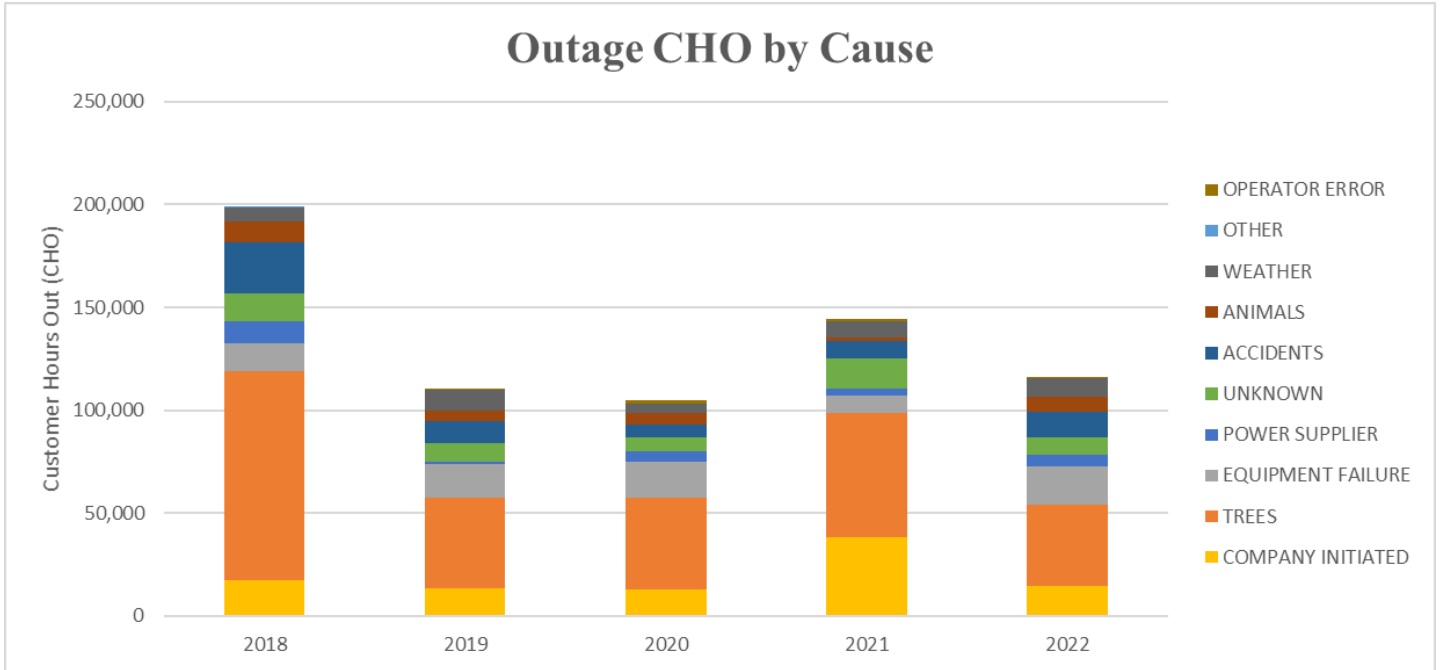
VEC experienced 115,825 customer hours out (CHO) in 2022 and averaged 134,837 hours out per year over the five-year period between 2018 and 2022. The chart below identifies outage duration by cause for 2018-2022.

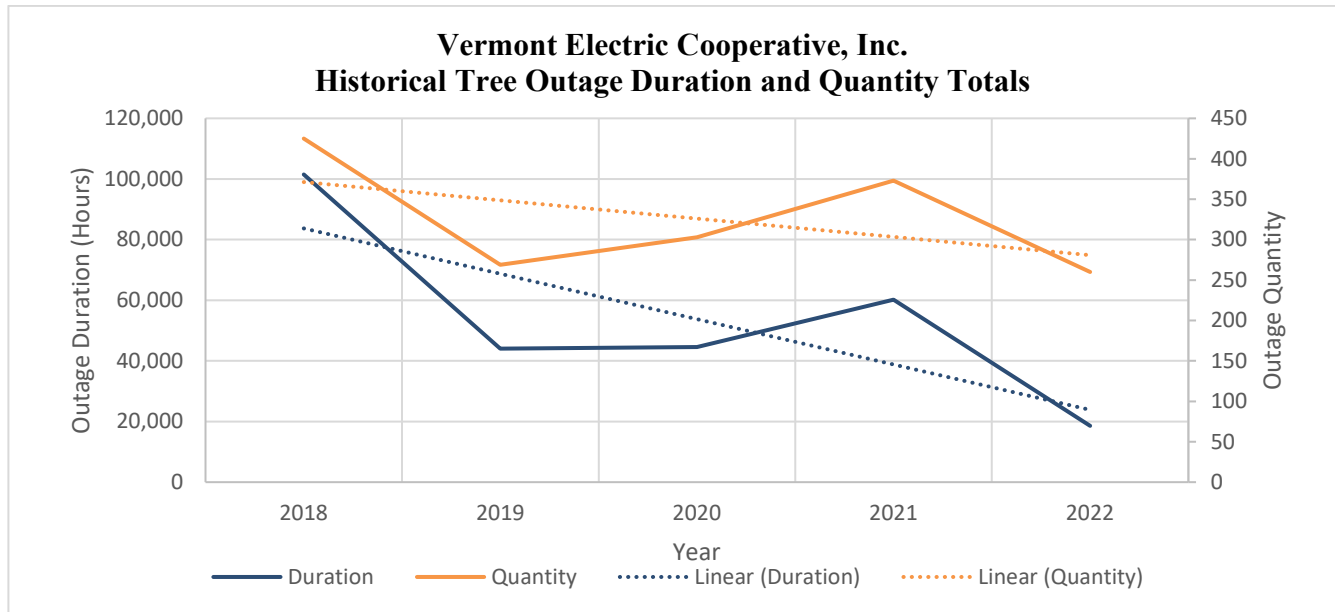
For 2022, tree outages rank first in customer hours out and second in outage quantity. Tree outages typically occur due to severe weather such as strong winds, heavy snow, and ice. The chart below shows a comparison of outage duration, quantity, and a five-year trend line which is decreasing.

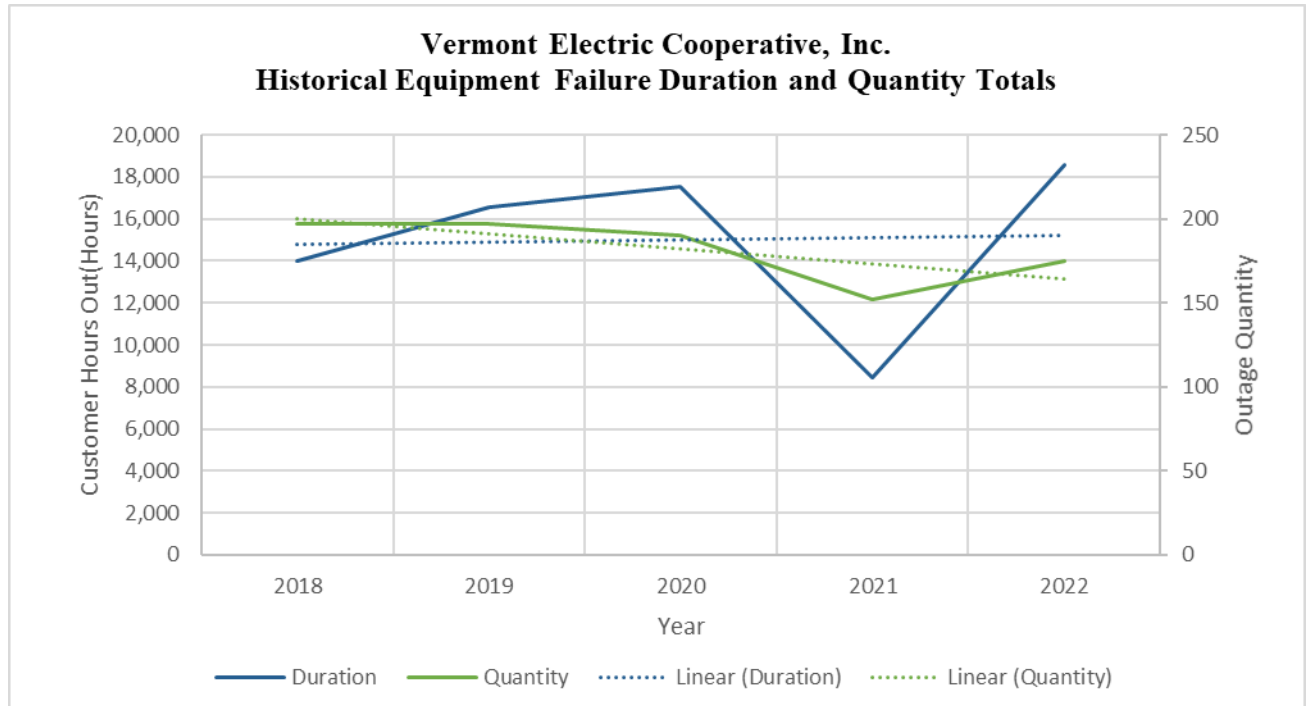
Equipment failure related outages rank second in customer hours out and fourth in outage quantity in 2022.

2022 experienced an increase in quantity but significant duration from equipment failure related outages. Significantly longer patrol times were needed to find some of the causes for them such as a failed lightning arrester on a Newport line with 600 members being served and an ‘untied’ or floating line conductor in East Berkshire.

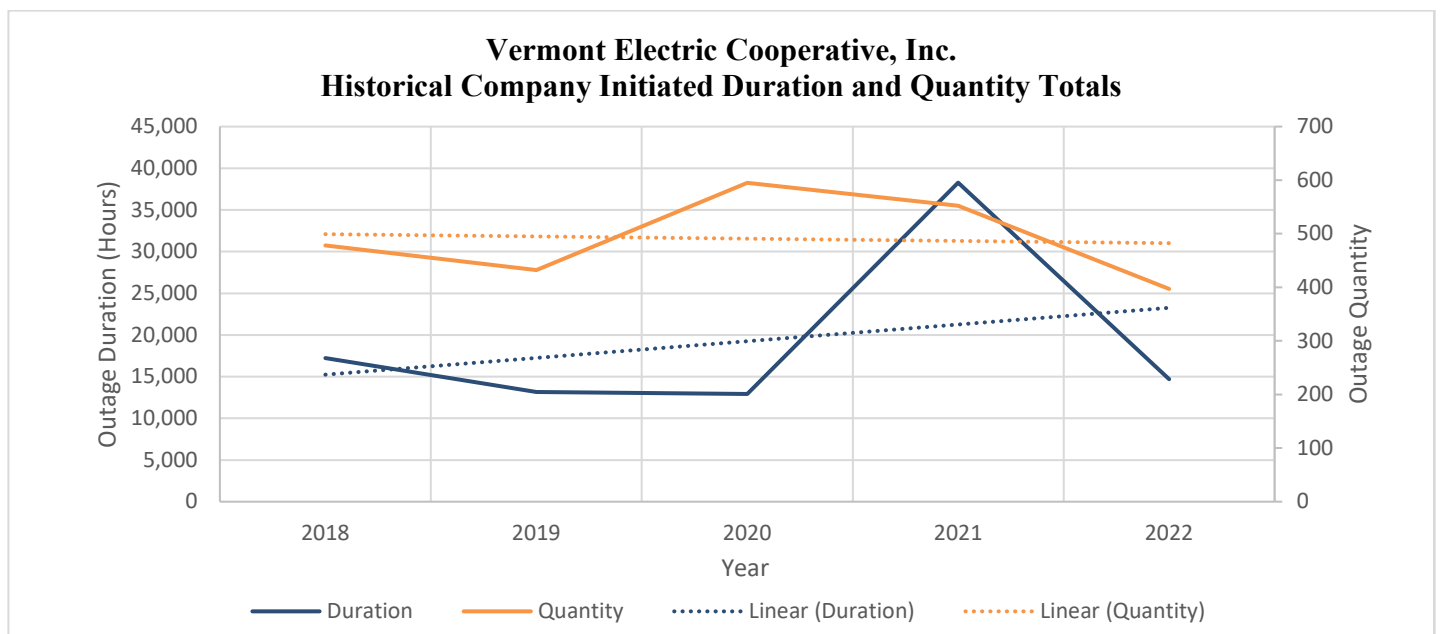
Company initiated outages rank third in customer hours out and first in outage quantity in 2022.

The past year saw company-initiated outage quantity and hour duration at their lowest in five years. Capital improvements (e.g., line relocations, equipment replacements, voltage conversions, etc.) continue to be the primary driver of this outage category.

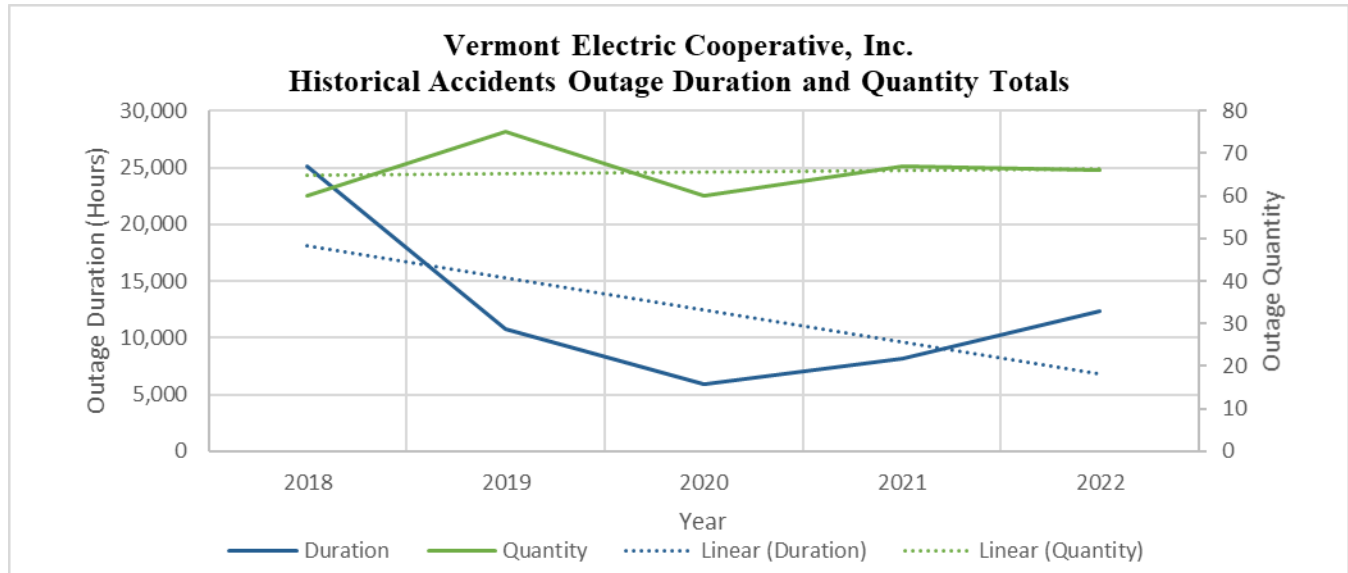
Accidents rank fourth in customer hours out and seventh in outage quantity in 2022.

Member caused outages, such as car-pole accidents and trees cut into proximity of power lines, are the largest share of accident related outages. VEC’s Safety Department has a policy to follow up with members after tree incidents to review the safety hazards that exist. VEC also encourages our members to notify VEC should they plan to conduct activities in close proximity to electric facilities in the future. Car-pole accidents, especially those involving three-phased poles, are also a large contributor to Customer Hours Out due to accidents.

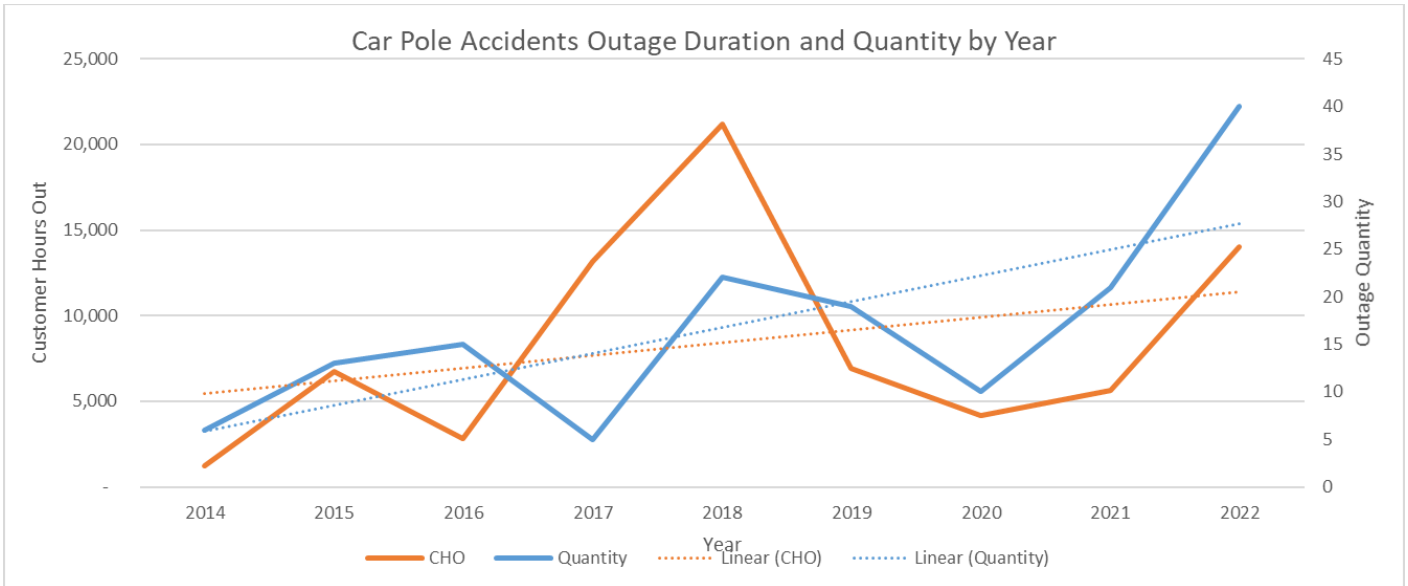
The number of car-pole accidents increased significantly, whereas the number of customer hours out due to such accidents decreased in 2022. The nature and location of these accidents has a significant impact on the duration of car pole outages. Two pictures of a three-phase car pole accident are included after the chart below. This was a significant outage that took over eight hours to repair.

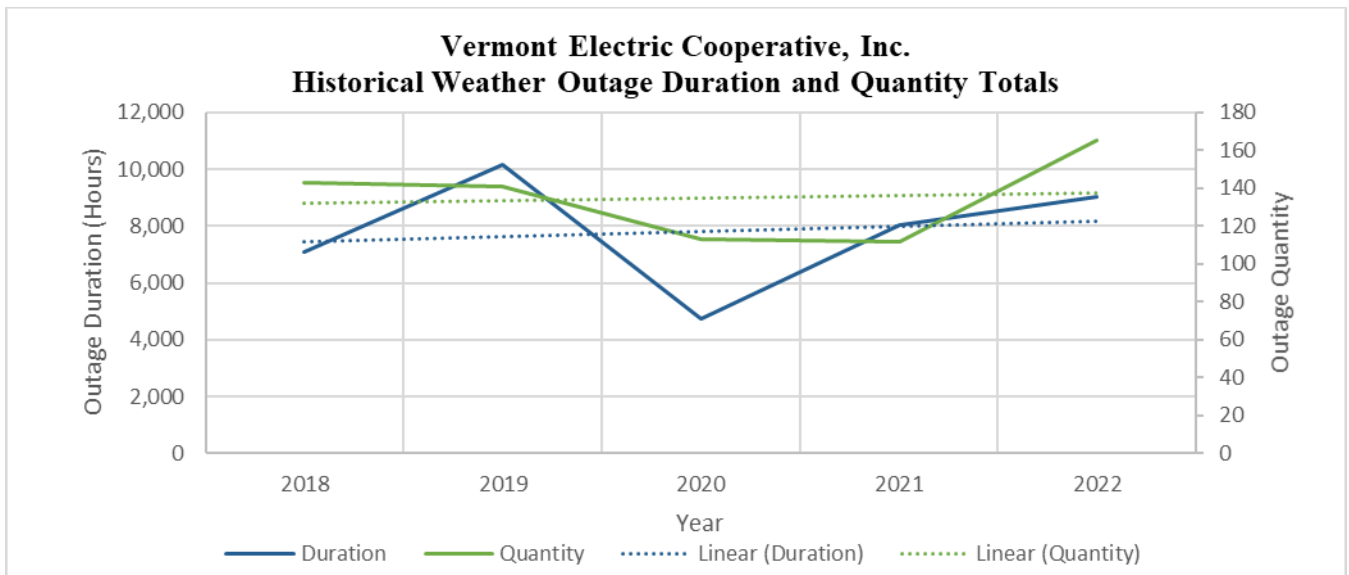
Weather related outages rank fifth in customer hours out and fifth in outage quantity in 2022.

The primary causes of these outages were snow unloading and lightning. The general trend is that weather-related outages are decreasing. However, per PUC guidelines, VEC codes any tree related outages caused by severe weather such as strong winds, heavy snow, and ice as tree outages, not weather. Refer to Section 5.1, Northview Weather, for more discussion on VEC's initiatives around climate analysis to drive asset investment.

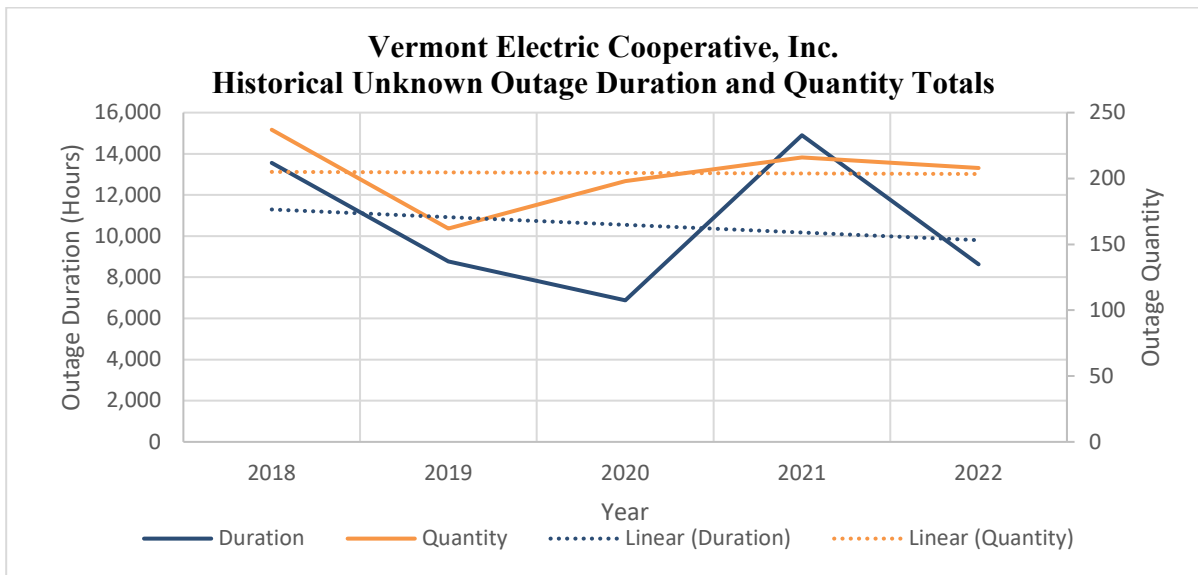
Unknown cause outages rank sixth in customer hours out and third in outage quantity in 2022.

VEC Line Operations reviews each unknown outage to attempt to determine the cause, but in many cases, we could find no concrete evidence of the cause.

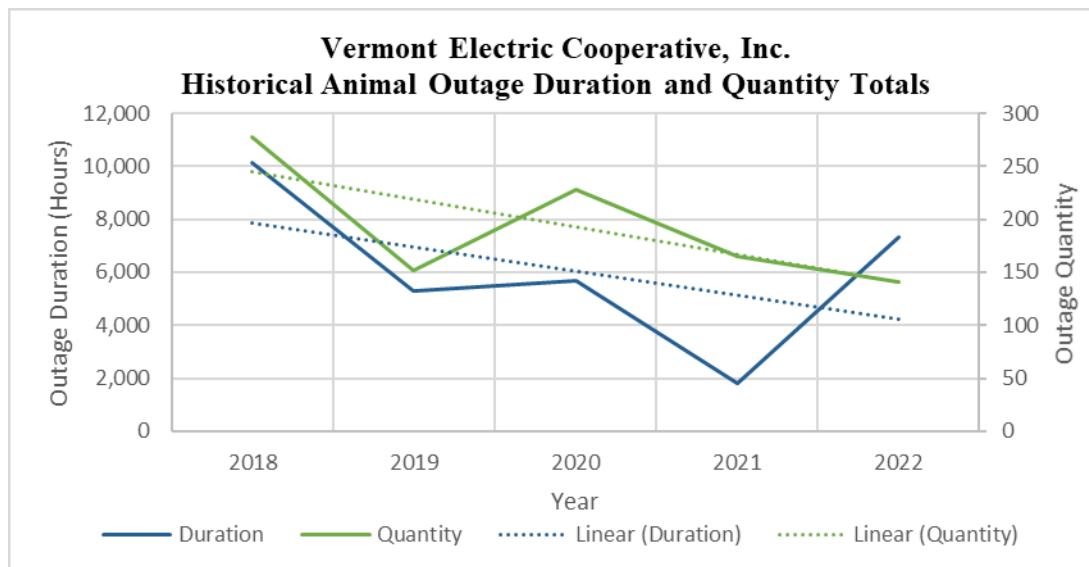
Animal outages rank seventh in customer hours out and sixth in outage quantity in 2022.

88 percent of these outages are caused by squirrels and birds on equipment without animal protection such as transformers, insulators and lightning arresters (equipment without guards). While VEC has animal protection on the majority of its system, VEC has a number of transformers without adequate protection on gap arresters. In addition, VEC has found that many of the older style animal protectors allowed birds to peck at bugs inside the arrester protection cap. In 2018, VEC updated its standards for distribution transformer wildlife protection and now

The overall trend for the number of Animal Outages is decreasing however, the duration increased in 2022 due mainly to the location of the outage, particularly a racoon got inside the Lowell substation distribution bus and an Osprey caused the outage of the South Alburgh substation's 1A feeder. Both outages were restored in average time of approximately 2 to 3 hours however included more members than usually associated with animal caused outages.

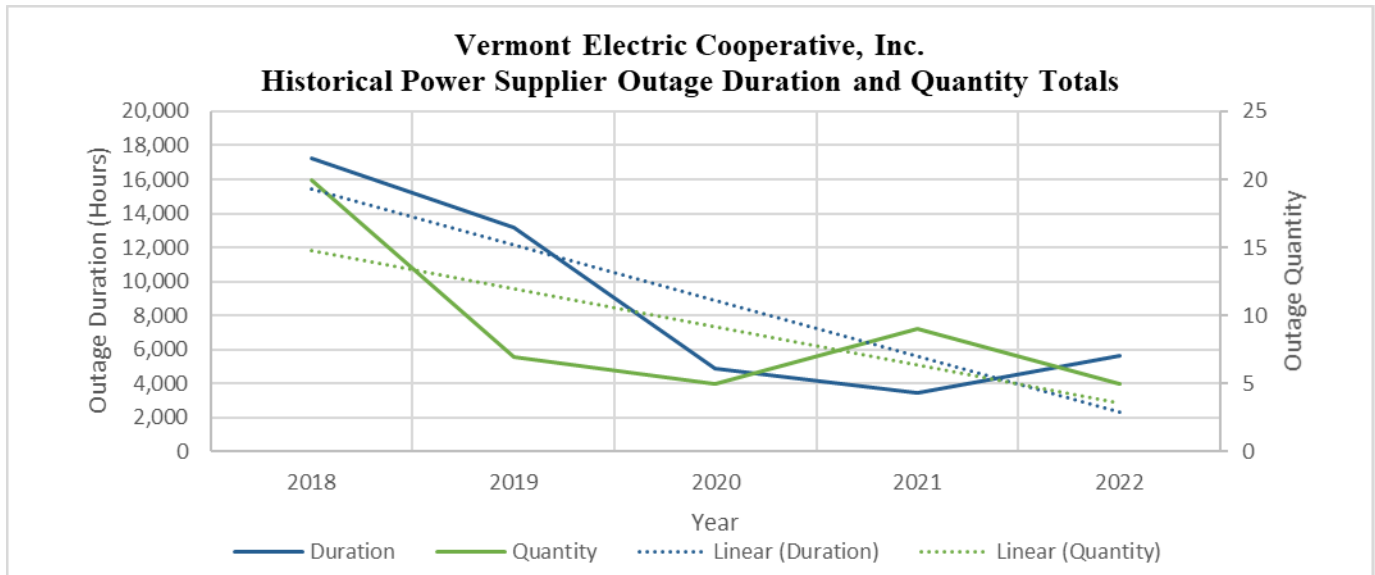
Power Supplier outages rank eighth in customer hours out and ninth in outage quantity in 2022.

Power supplier outages have continued to trend lower since 2018.

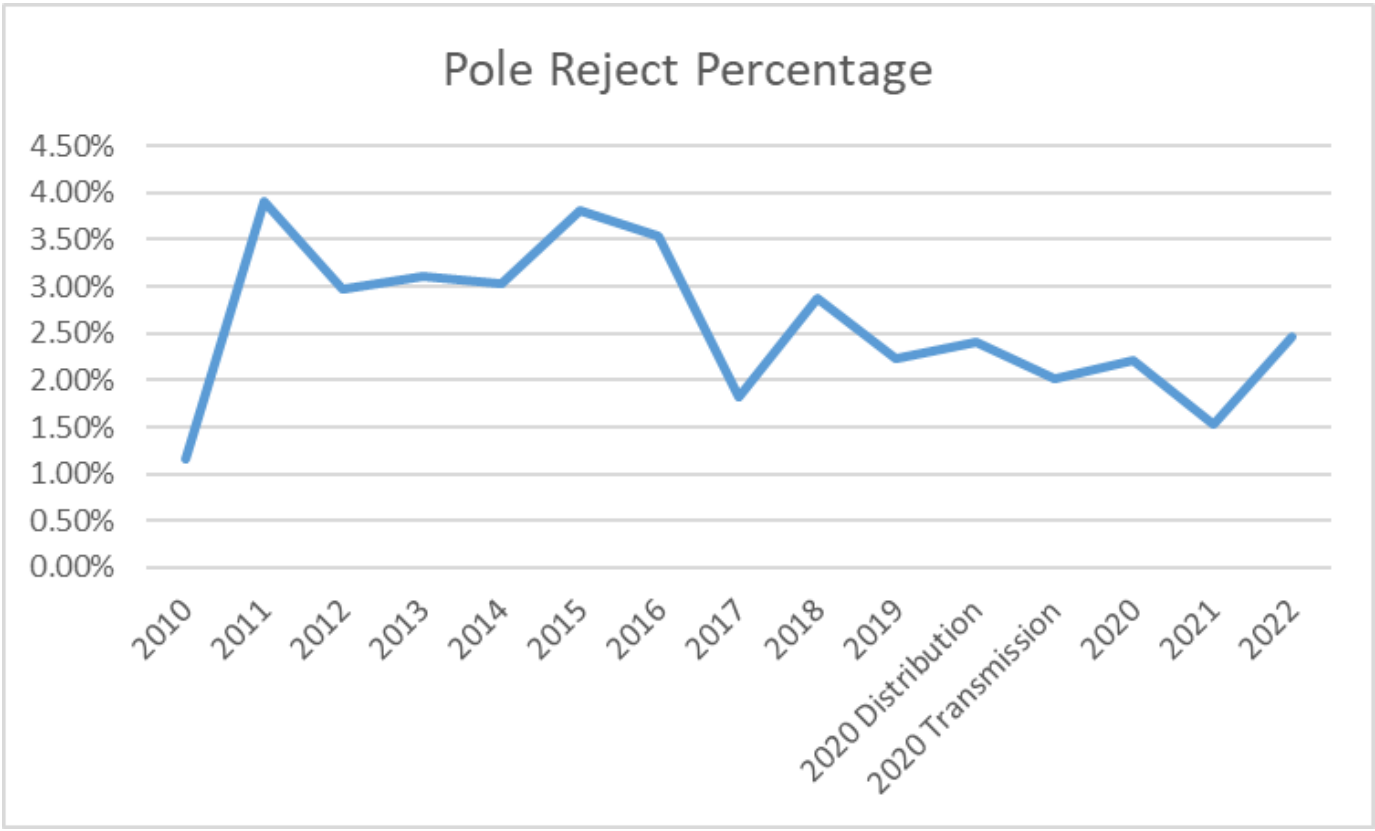
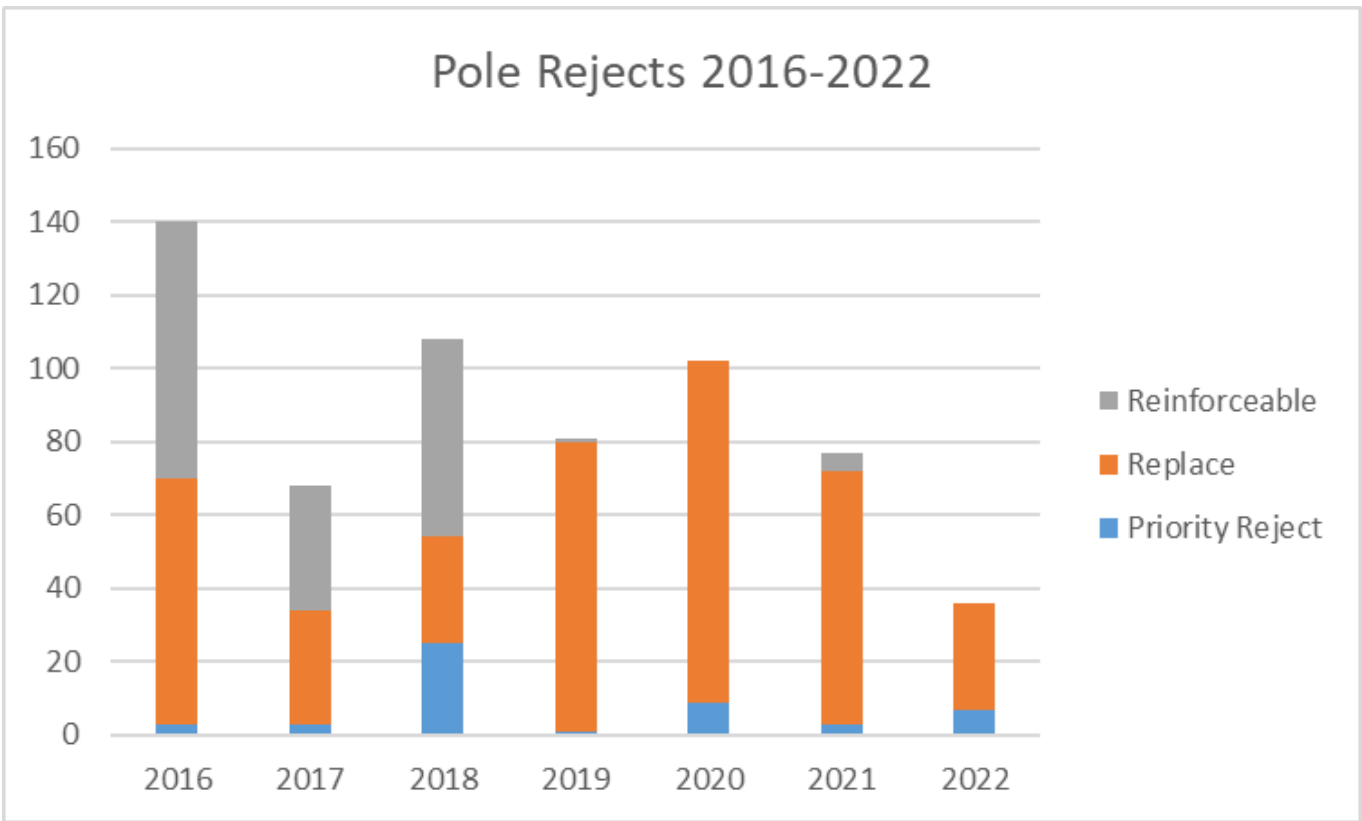
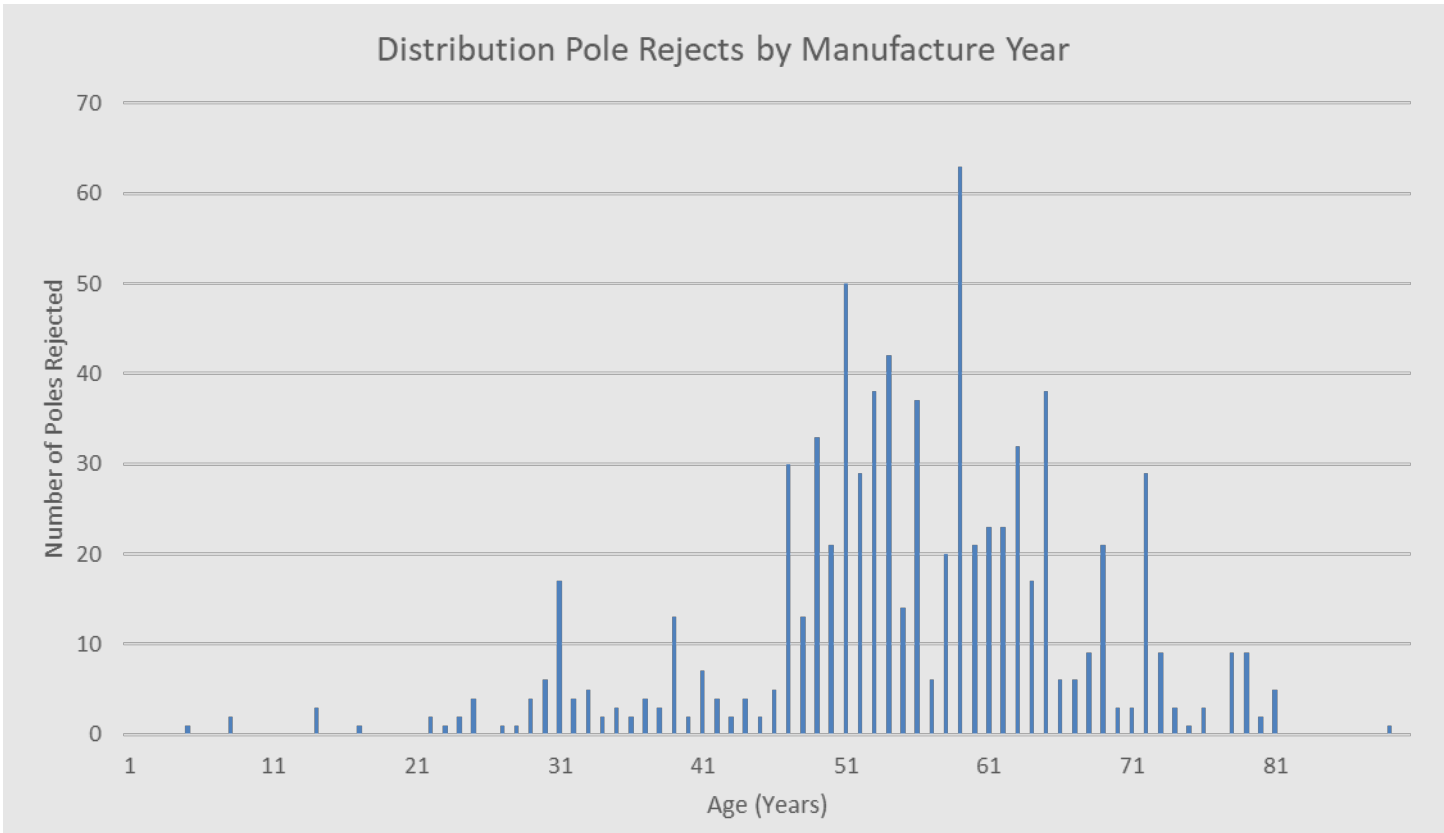
VEC completed its first distribution and second transmission 10-year cycle of our pole inspection process last year. Our average reject percentage was 2.68 percent. VEC hired Alamon to complete the pole inspection program in 2021 and they identified 77 reject poles. Alamon got a late start this year due to staffing changes and identified 36 reject poles by end of year.

The average age of rejected poles is 58 years old (manufactured in 1963).

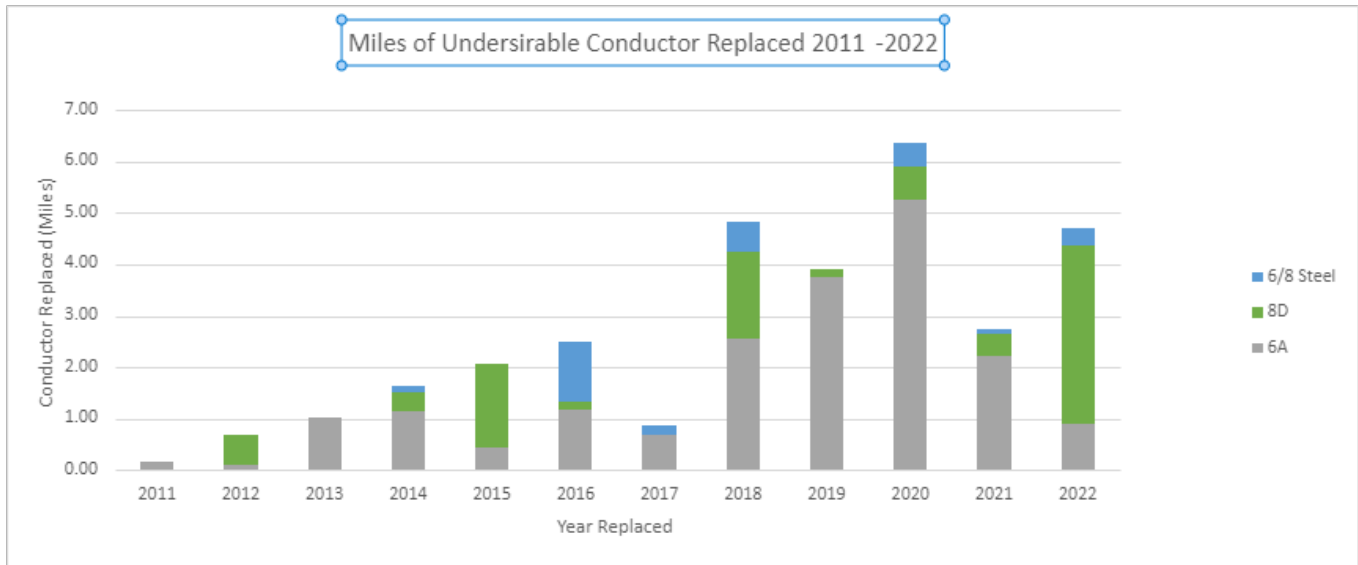
VEC has prioritized building infrastructure that allows for feeder backup, replacement of obsolete wire (overhead and underground), and relocation of lines from hard-to-access ROW to the roadside. In 2023, VEC plans on reconductoring around eight miles of obsolete wire and relocating 2.2 miles from difficult to access rights-of-way to the road.

VEC retired almost five miles of 8D, 6A, and 6/8 steel in 2022.
